WEEKLY OVERSIGHT REPORT

Weekly Summary Report

USEPA Oversight, Sauget Area 2, Sauget, IL

Week Ending Friday April 9, 2004

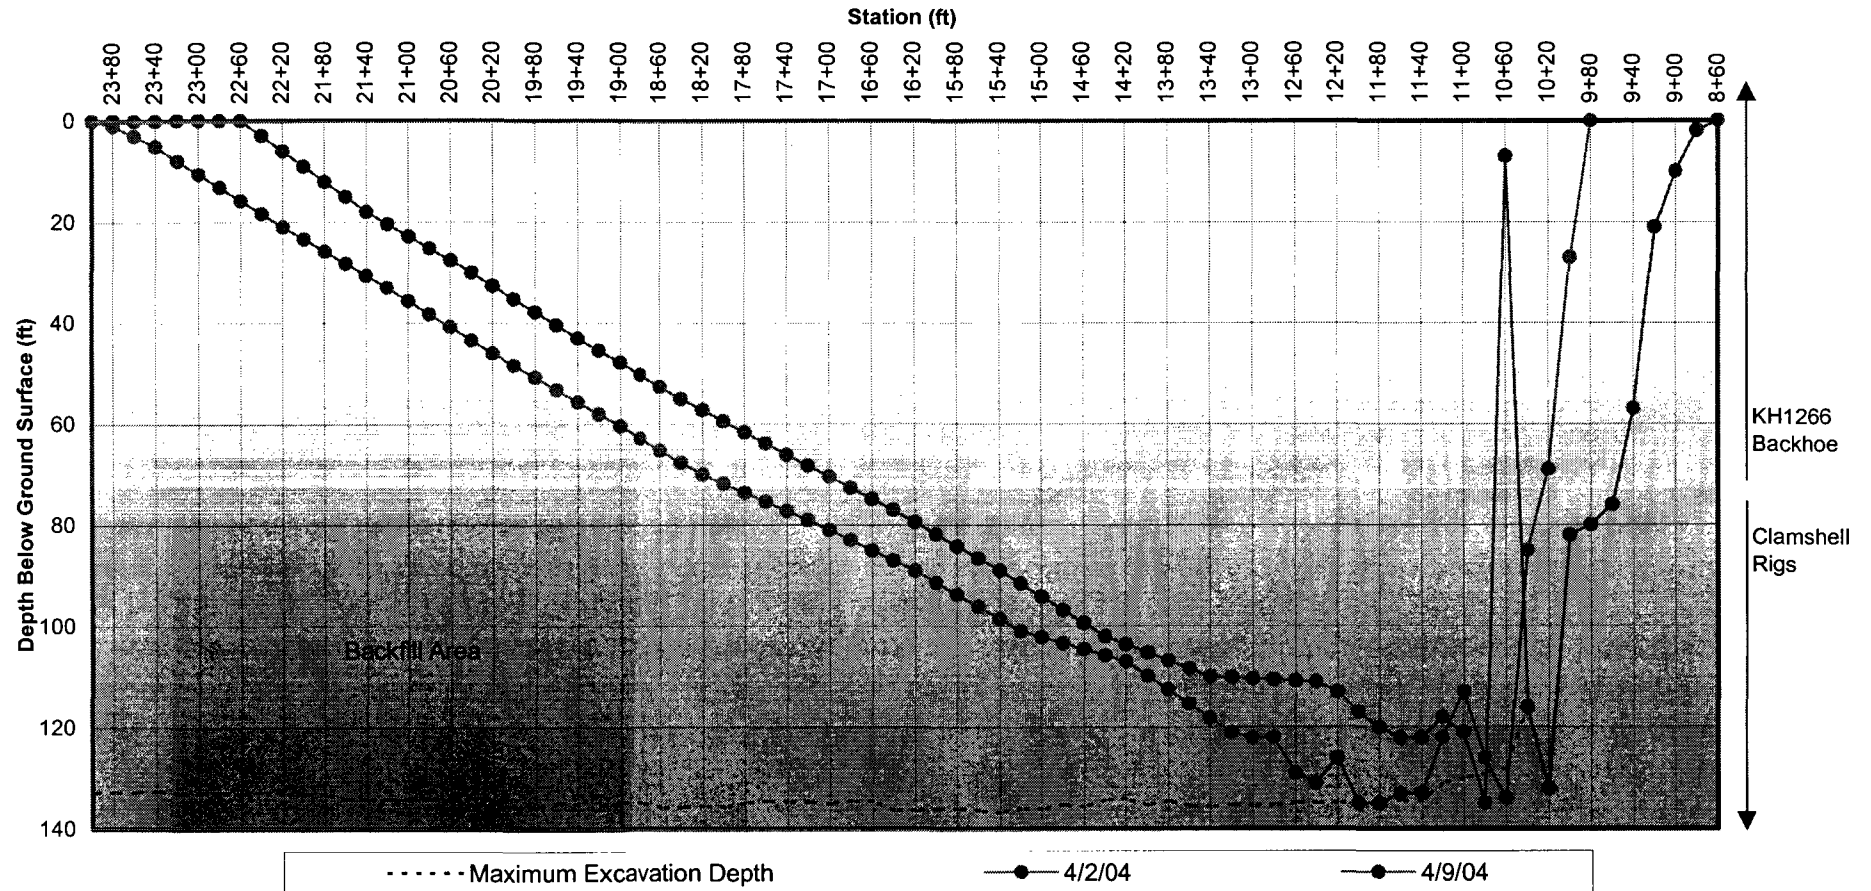
**Graph 1 - Weekly Barrier Wall Construction Progress
April 5 to April 9, 2004**

Note: Data plotted for week through AM measurements on 4-2-04 and PM measurements on 4-9-04.
Some data points are interpolated between the available data points where trench depth measurements were read.

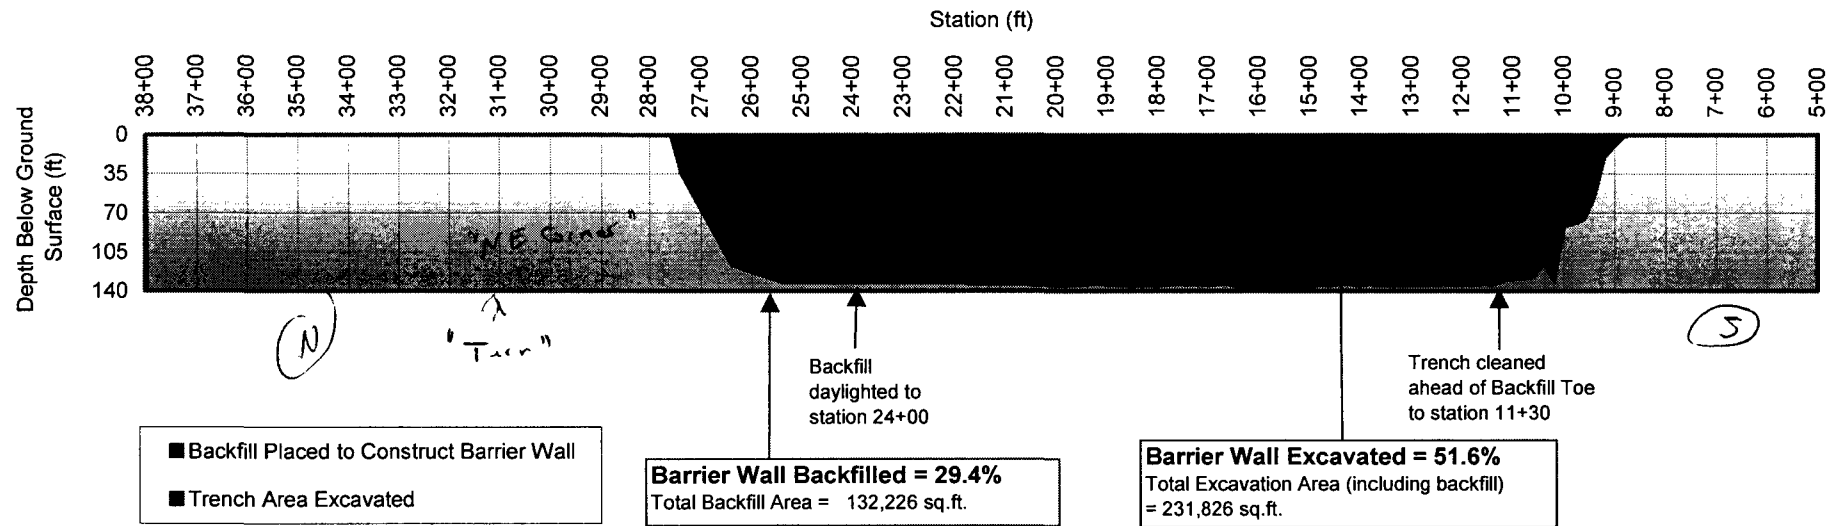
Graph 2 - Barrier Wall Construction Progress by April 9, 2004 (PM)

Note: Data plotted for week through PM measurements on 4-9-04.

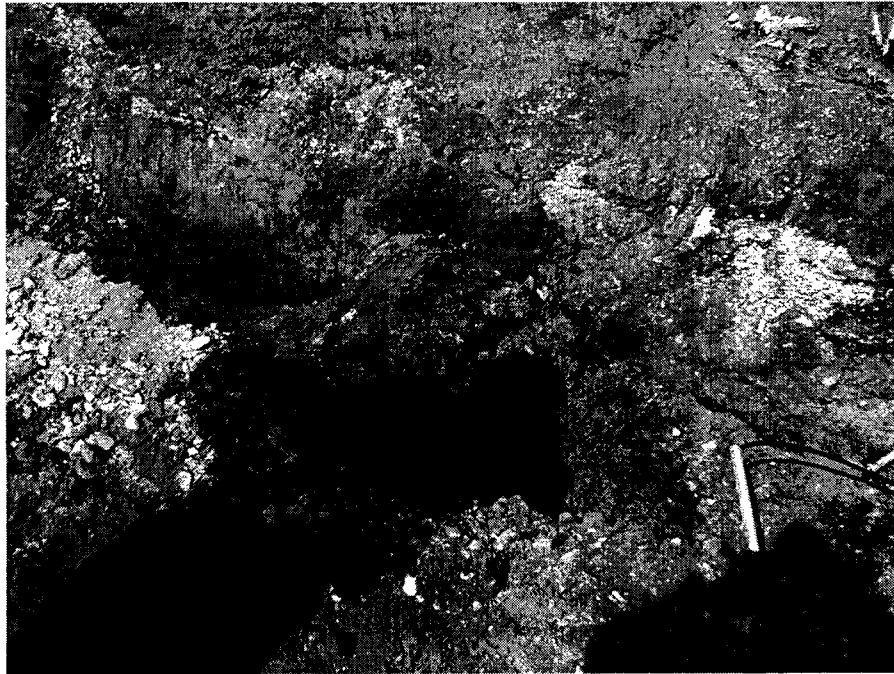
On April 9, 2004 at approximately 9:00 AM, while pretrenching with the small trackhoe for the second panel in the barrier wall alignment to the south of the box culvert location, in the northwest corner of the site, the control wiring encased in conduit to all four downgradient piezometers (P1N, P2W, P3W, and P4W) and the river level gauge was broken. Excavation in the area immediately halted, extraction well pumping for the GMCS system was unaffected. The wiring and conduit was repaired by 3:00 PM on April 9, and the conduit was placed inside a metal pipe perpendicular to the barrier wall alignment. Water level elevations at these five locations were not recorded in the six hours during which the wiring was being repaired. Next week, URS intends to encase the metal pipe housing the control wiring in concrete to protect it during subsequent excavation in the area.

Broken piezometer wiring and conduit on the north end of Site R (April 9, 2004).
